# Corrosion in Through-Hull Fittings and seacock valves in yachts and boats

By M.Sc. Eng, Naval architect and corrosion specialist Piet Jansen

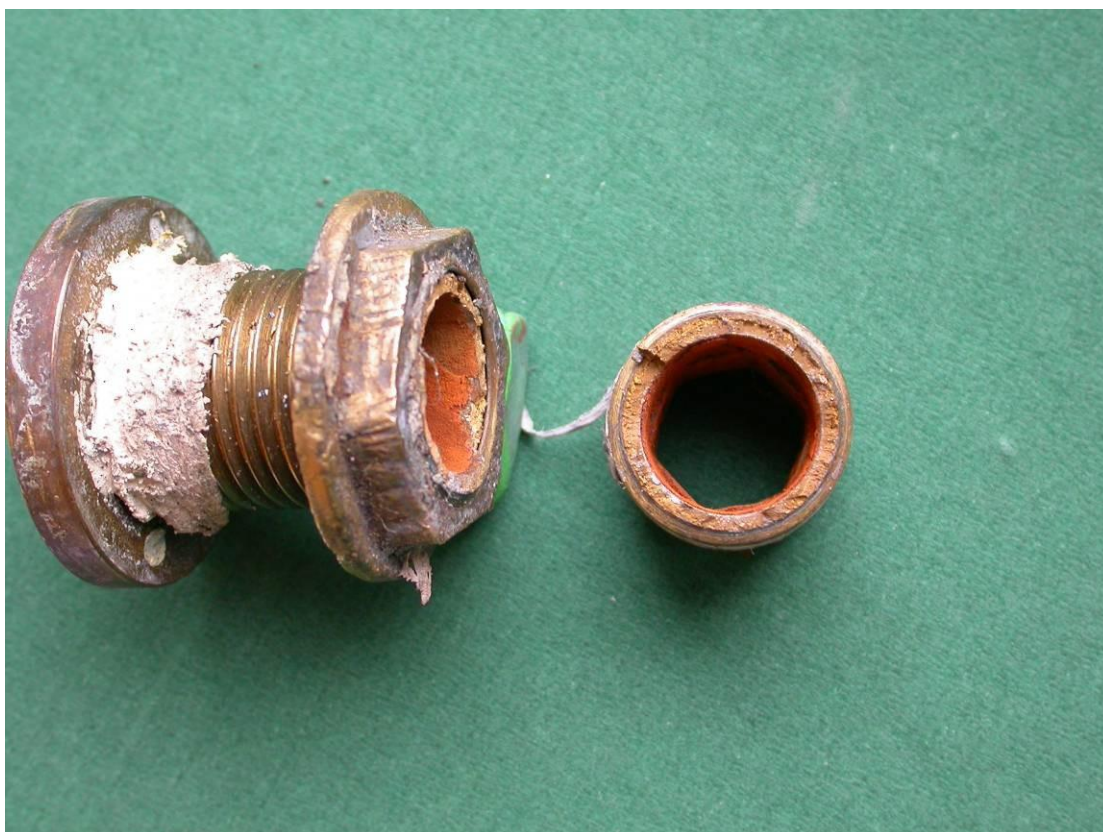
Figure 1 Hull fitting for cooling water, made of brass, broken in the thread inside the boat. Possibly due to ammonia stress corrosion.

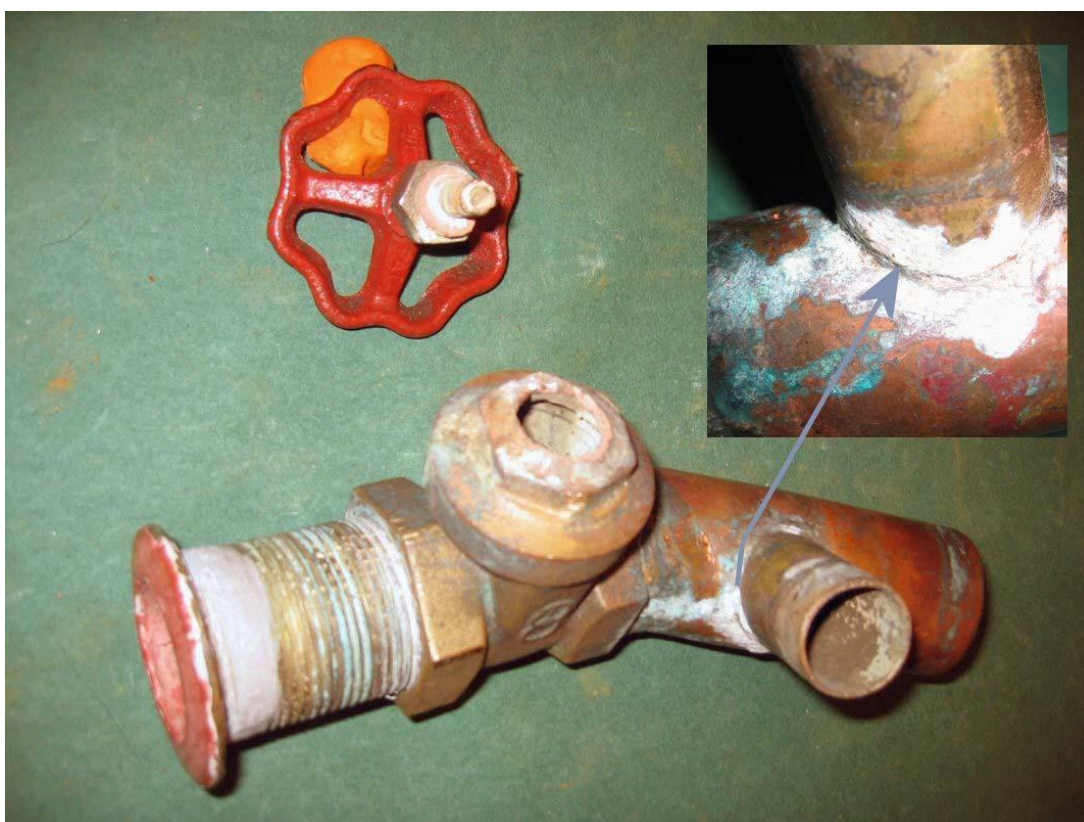
Figure 2 Dezincification and broken gate sea cock valve. The cover has broken off causing a major leak and major ingress of seawater into the boat.

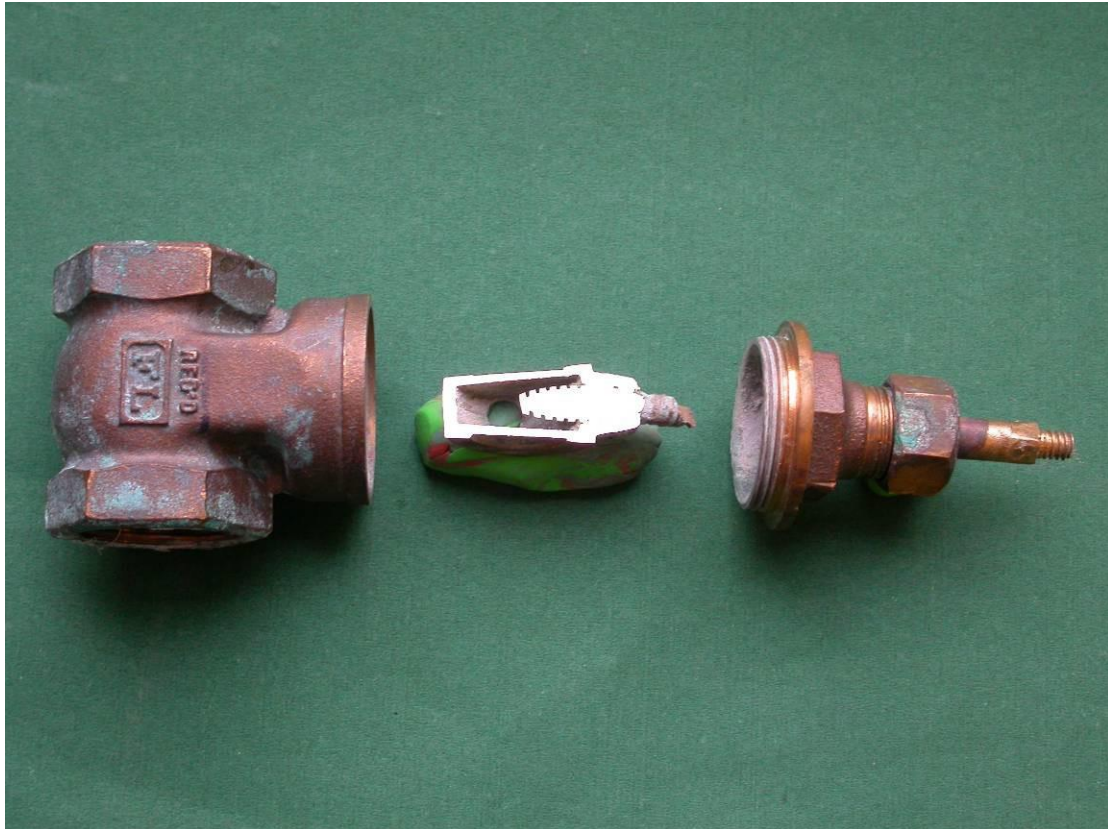
Figure 3 Old gate sea cock valve made from gun metal housing and stem. The brass spindle is attacked by dezincification corrosion and has jammed and finally broken.

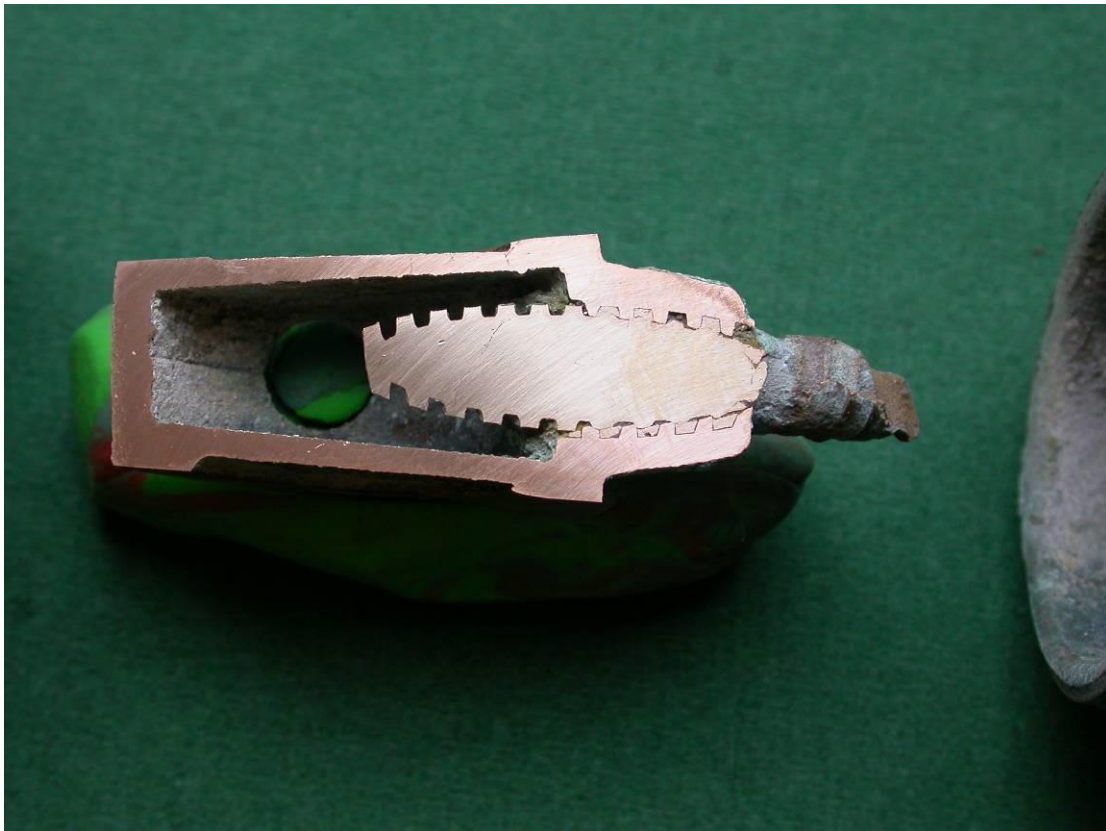
Figure 4 The broken spindle in the stem. The colour difference between the light yellow brass and the red-yellow bronze is obvious here. The brass metal is attacked by dezincification corrosion causing the spindle to jam and break.

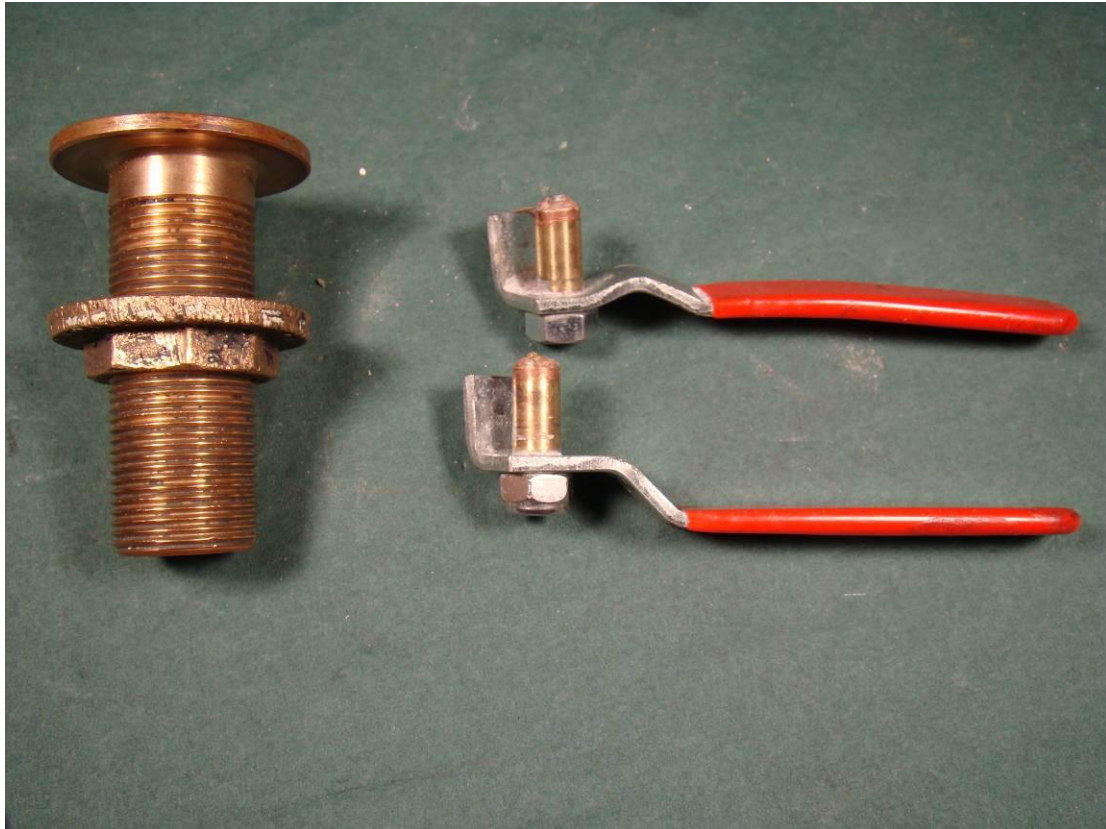
Several of the available new ball valves in the marine shops, which are intended used as sea cock valves, look correct with a bronze/gunmetal house/body in the correct reddish colour. However, you cannot be sure, unfortunately. At the market you may find e.g. Italian valves (labelled "ITALY" in the galvanised handle) with a shaft made from the poorest type of free cutting brass. Such valves will only last a couple of years, as the valve shaft will start corroding and start seizing due to dezincification. In the end it will become stuck and break, at which point you will have to pull the lever hard.

Figure 5 Replaced intact bronze hull fitting and two valve handles with broken brass shaft from "new" bronze ball valves. The shafts are made of non-dezincification resistant brass. The handle is marked "ITALY".

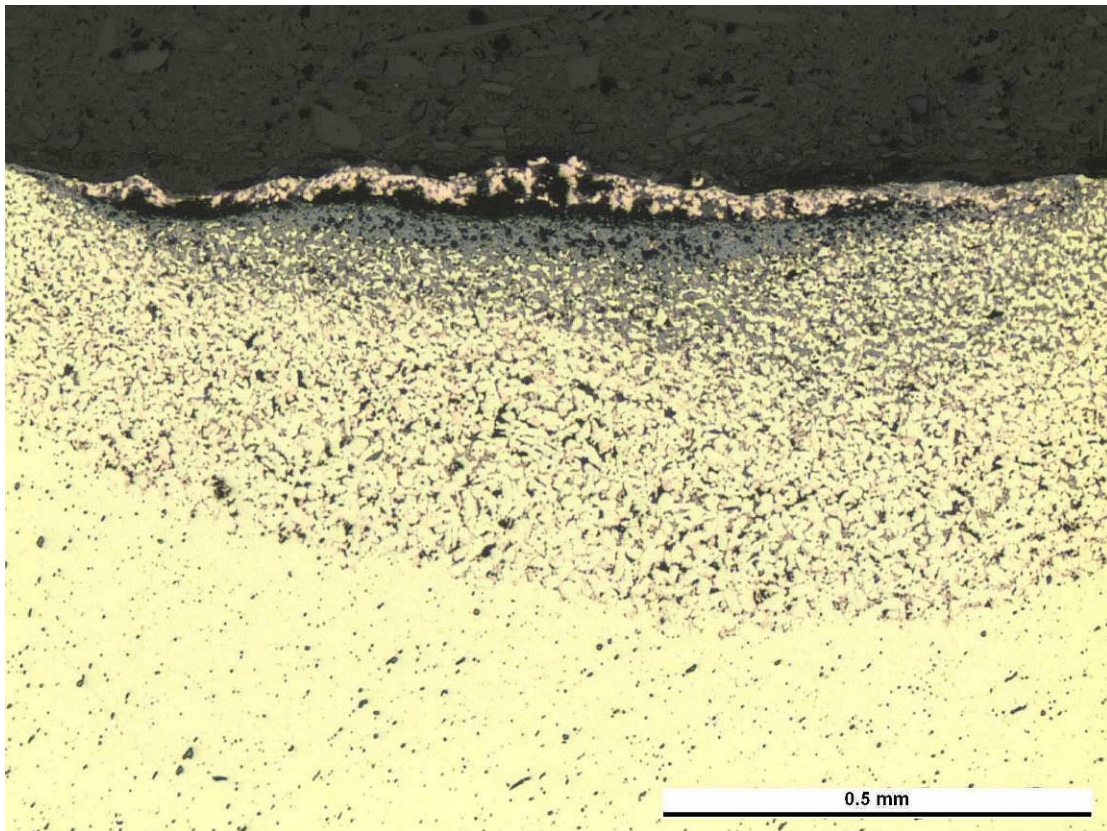
Figure 6 Attacks of selective corrosion seen as dezincification in the brass microstructure. This attack is still only 0.5 mm, but continues until the fitting will leak or break.

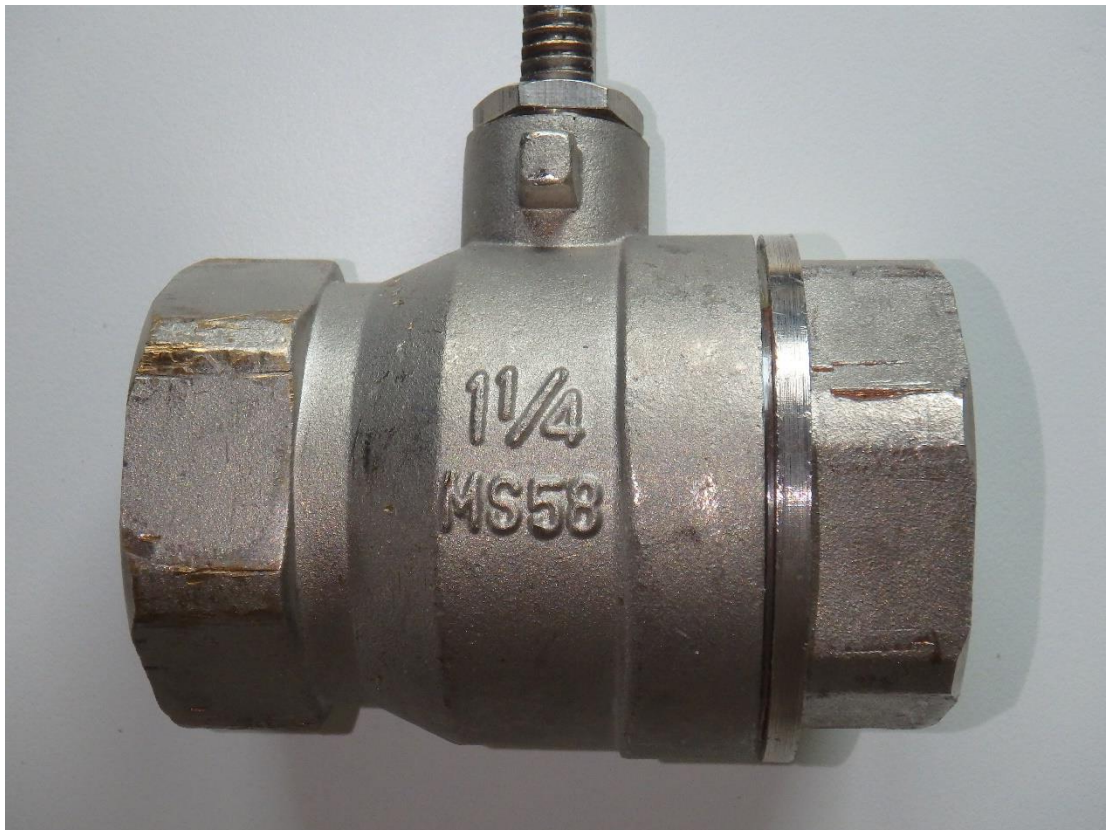
Figure 7

Many seacock valves are marked with the alloy material. It may be MS58 or CW617, as shown in figure 7. In old valves it might be the manufacturer's own material designation. With no marking to identify the alloy, the boat owner will have difficulties. For new parts it is important to check the marking so that the boat owner is not just replacing the old ones with new parts made from a poor brass material.

Brass alloy MS58 ball valve. The valve is Nickel coated on the outer side. The internal parts are attacked by dezincification corrosion. The material is intended for fresh water not seawater. MS58 is an old Danish material designation for CW617

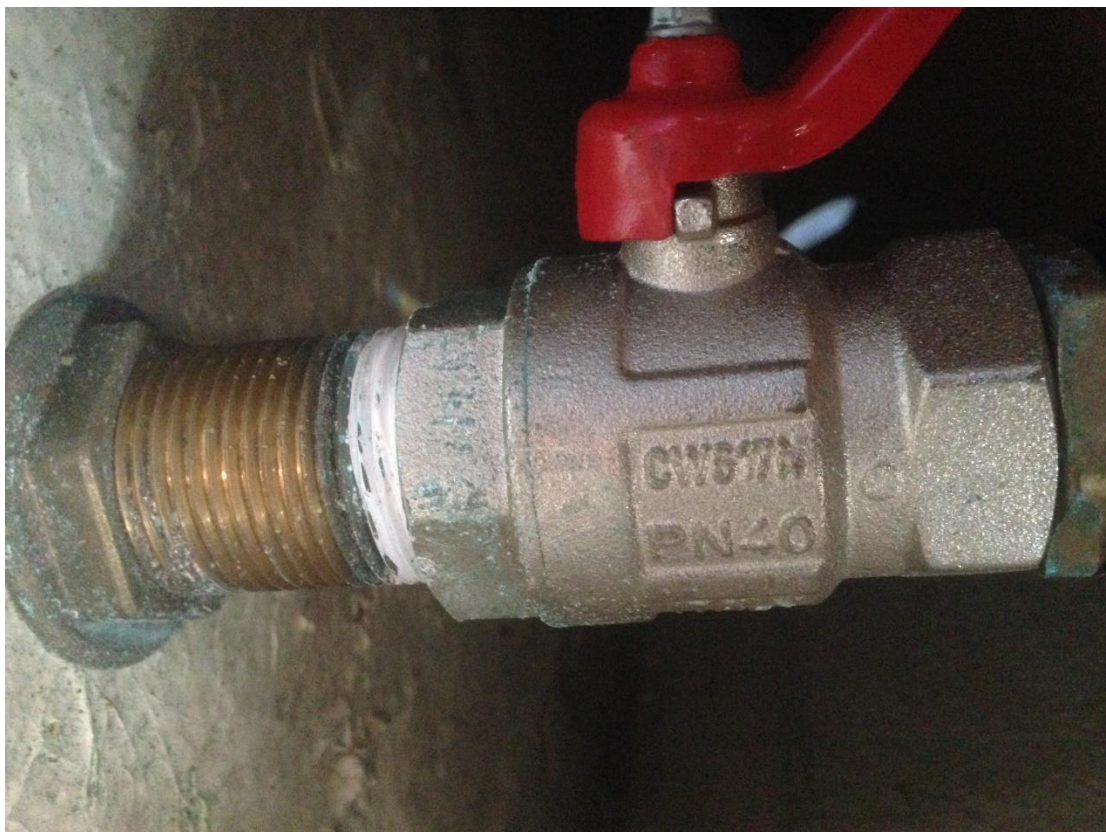
Figure 8

Brass alloy ball valve marked with CW617. The valve is Nickel coated on the outer side. Possibly, the internal parts are attacked by dezincification corrosion. The material is intended for fresh water not seawater.

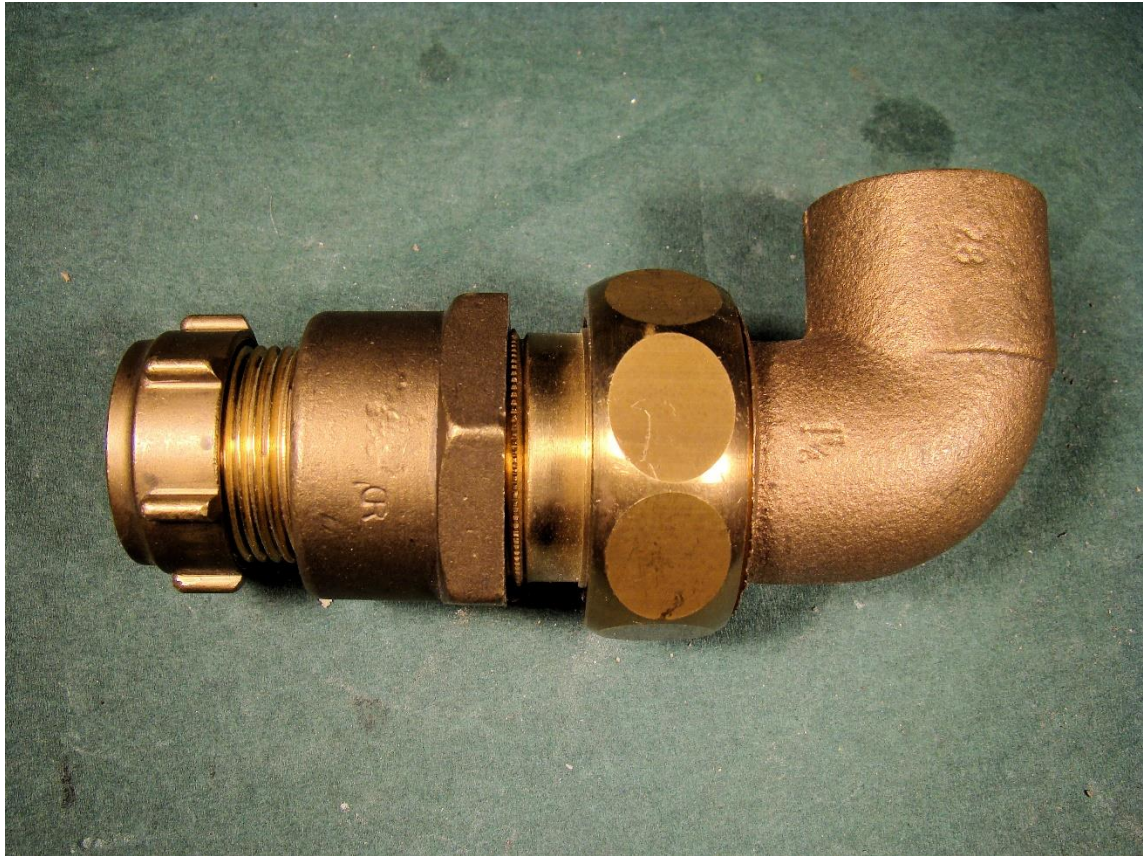
Figure 9      Combination of yellow brass fittings and reddish gunmetal bronze pipe-bend  
Note the colour difference.
